AVIATION INVESTIGATION REPORT
A04W0200

NAVIGATION DEVIATION

GOVERNMENT OF CANADA
DEPARTMENT OF TRANSPORT
BEECH KING AIR C90A C-FGXH
EDMONTON, ALBERTA
10 SEPTEMBER 2004

Report Number A04W0200

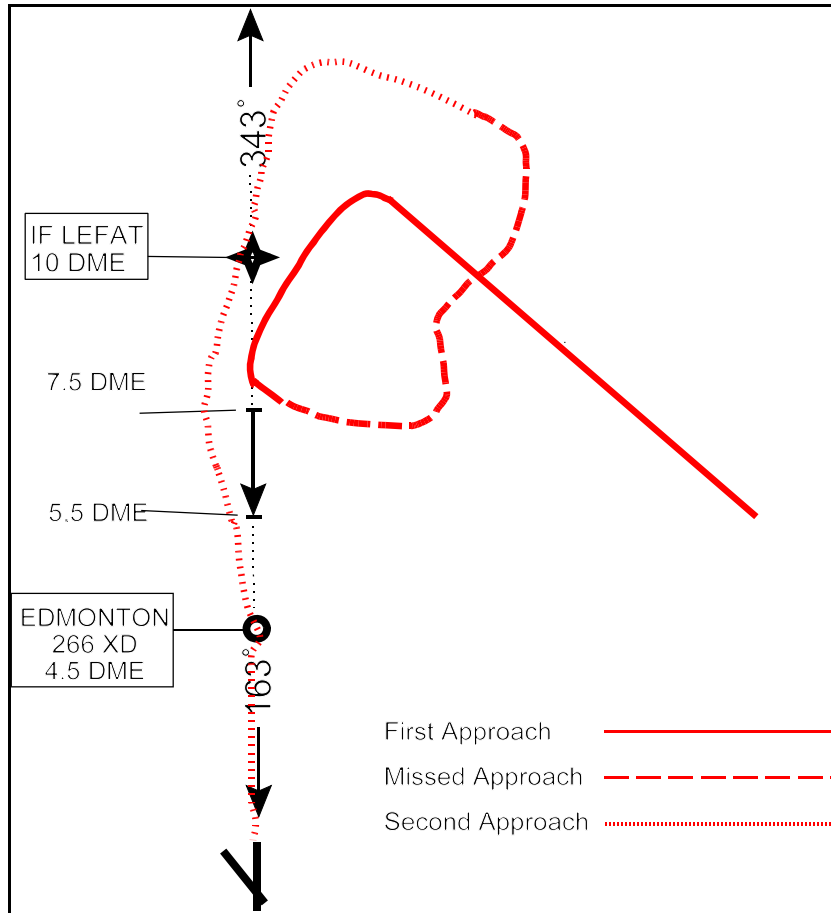
Figure 1. Plan view of approaches at CYXD

Prior to descent, the crew briefed the expected LOC (BC) DME RWY 16 instrument approach to CYXD. When the aircraft was 2.5 nautical miles (nm) from intercepting the localizer, the Edmonton terminal arrival controller vectored the flight to intercept the approach inbound course at the minimum sector vectoring altitude of 4100 feet, and cleared it for the approach. (See Appendix A, Figure 1.)

Upon intercepting the localizer at 8.8 nm from the threshold, the aircraft immediately turned off course to the left. The FO initiated a missed approach by disengaging the autopilot, increasing pitch attitude, and increasing power. Shortly afterward, the airspeed was observed to decrease to about 90 knots indicated air speed (KIAS) before recovering to 130 KIAS. The minimum C90A single engine control speed (Vmca) was 90 KIAS, and the bailed landing initial climb speed was 101 KIAS. The FO did not refer to the flight director during the missed approach.

After the missed approach, the crew completed an abbreviated briefing for the second LOC(BC)/DME RWY 16 approach. They did not change the avionics settings. The FO flew the aircraft manually. On air traffic control (ATC) vectors, the aircraft was positioned to intercept the final approach track 10.7 nm from the Runway 16 threshold. The aircraft did not establish on track, and gradually drifted west to a maximum of 0.7 nm right of the approach centreline.

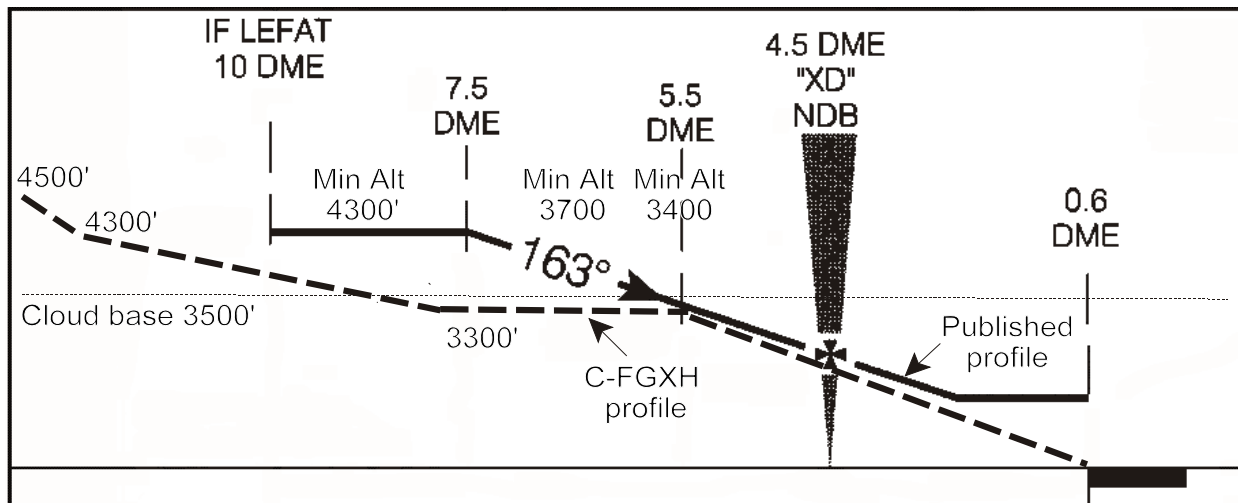
Figure 2. Profile view, second approach

During the approach, the captain gave their position as 4.7 DME (distance measuring equipment) when the aircraft was actually 10 nm from the airport because he had read the global positioning system (GPS) display of the distance to the final approach fix instead of the DME display. Radar data indicated that the aircraft descended to about 3500 feet, or 800 feet below the minimum step-down altitude of 4300 feet, before descending below the cloud base. (See Appendix A, Figure 2.)

The crew's dependence on GPS information resulted in their estimating their position as 4.5 nm closer to the airport than it actually was. The significant deviation from the approach centreline and the premature descent profile suggest that the crew did not have an accurate perception of their position in relation to the approach centreline or of their distance from the airport. Under the prevailing weather conditions, the aircraft would have been in cloud until it descended to about 1300 feet agl, and its margin of protection from obstacles would have been reduced.

4. On the second approach at Edmonton, the crew focussed on the GPS (global positioning system) distance reading from the final approach fix, instead of the DME (distance measuring equipment) display. This led to a premature descent, and the aircraft was operated below the minimum published step-down altitudes for the approach.
